**Report on flammability and HF exposure trials with vehicle air conditioning systems using R1234yf**

1. Introduction

Under EU Directive 2006/40/EC, from 1 January 2011 new EC type-approvals may only use a refrigerant with a GWP (Global Warming Potential) value of less than 150 in passenger vehicle (M1) air conditioning systems. For EC type-approvals issued before 1 January 2011, the existing refrigerant R134a may continue to be used until the end of 2016.

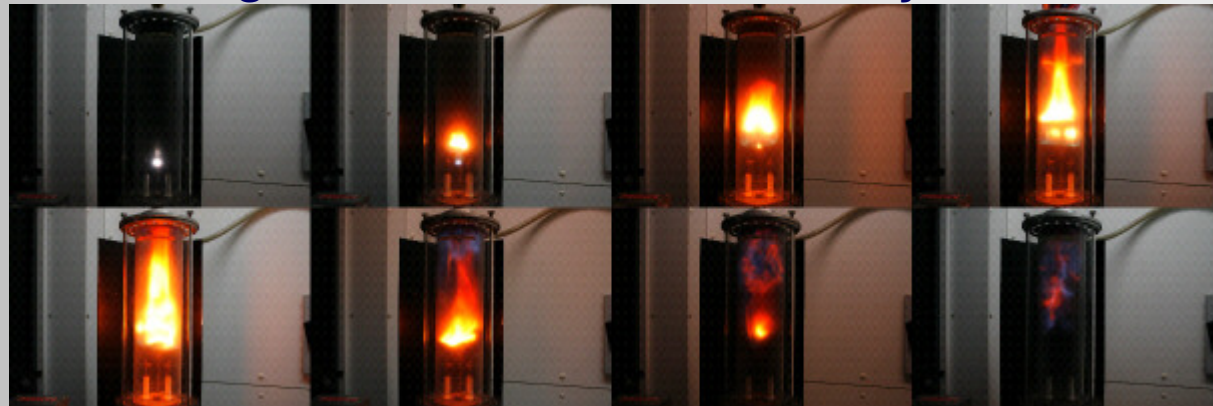
### Ignition at 13.0 mole-% R1234yf

**Pure R-1234yf can also burn with a bright yellow flame. The colour of the flame depends mainly on the concentration of the refrigerant.**

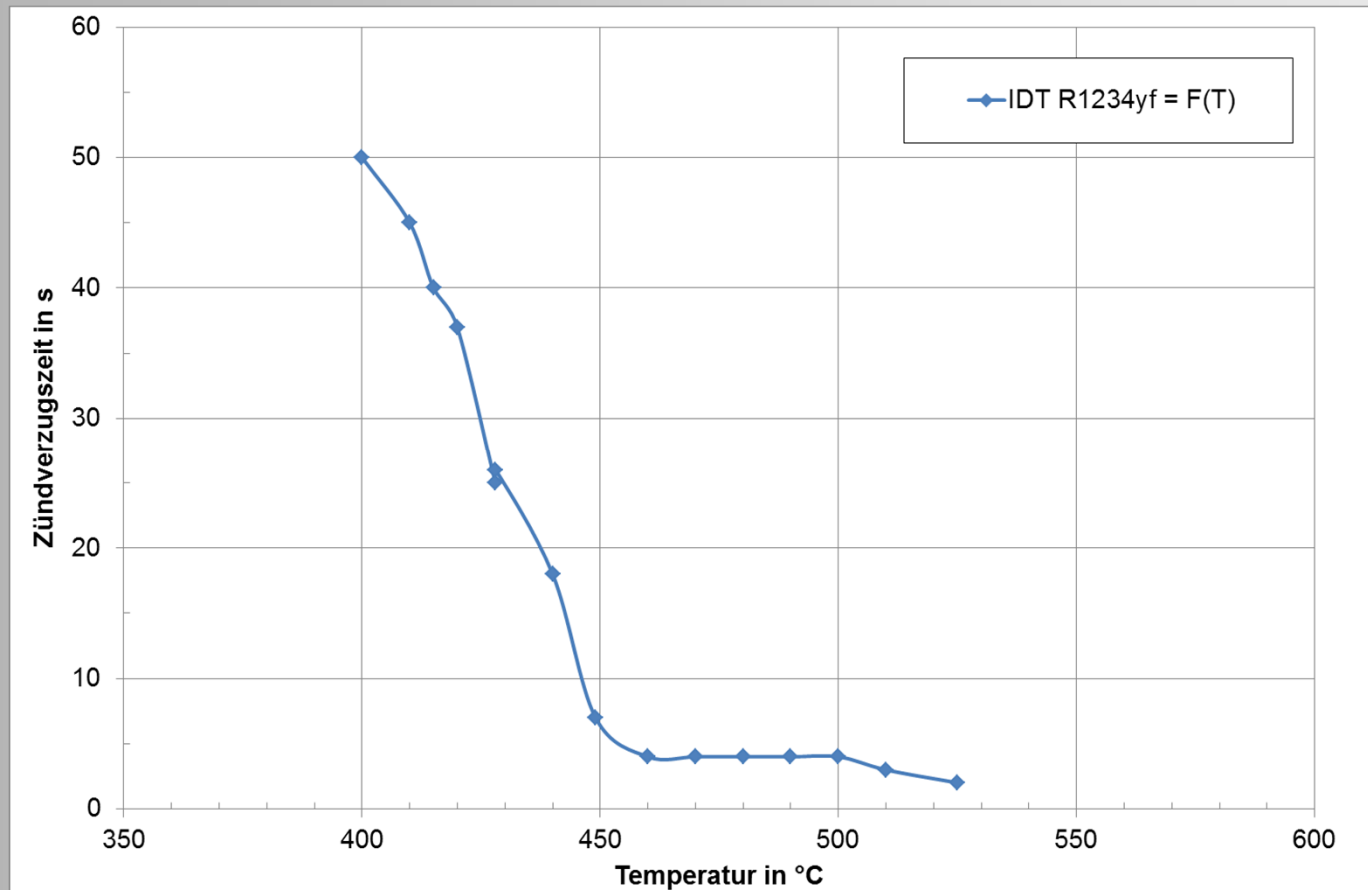
- Results  $IDT = f(T)$  -

**As surface temperature rises, the ignition delay time reduces. Taking account of the triggering time of 2s for 20ml of R-1234yf, at temperatures > 525 °C immediate ignition is to be expected.**

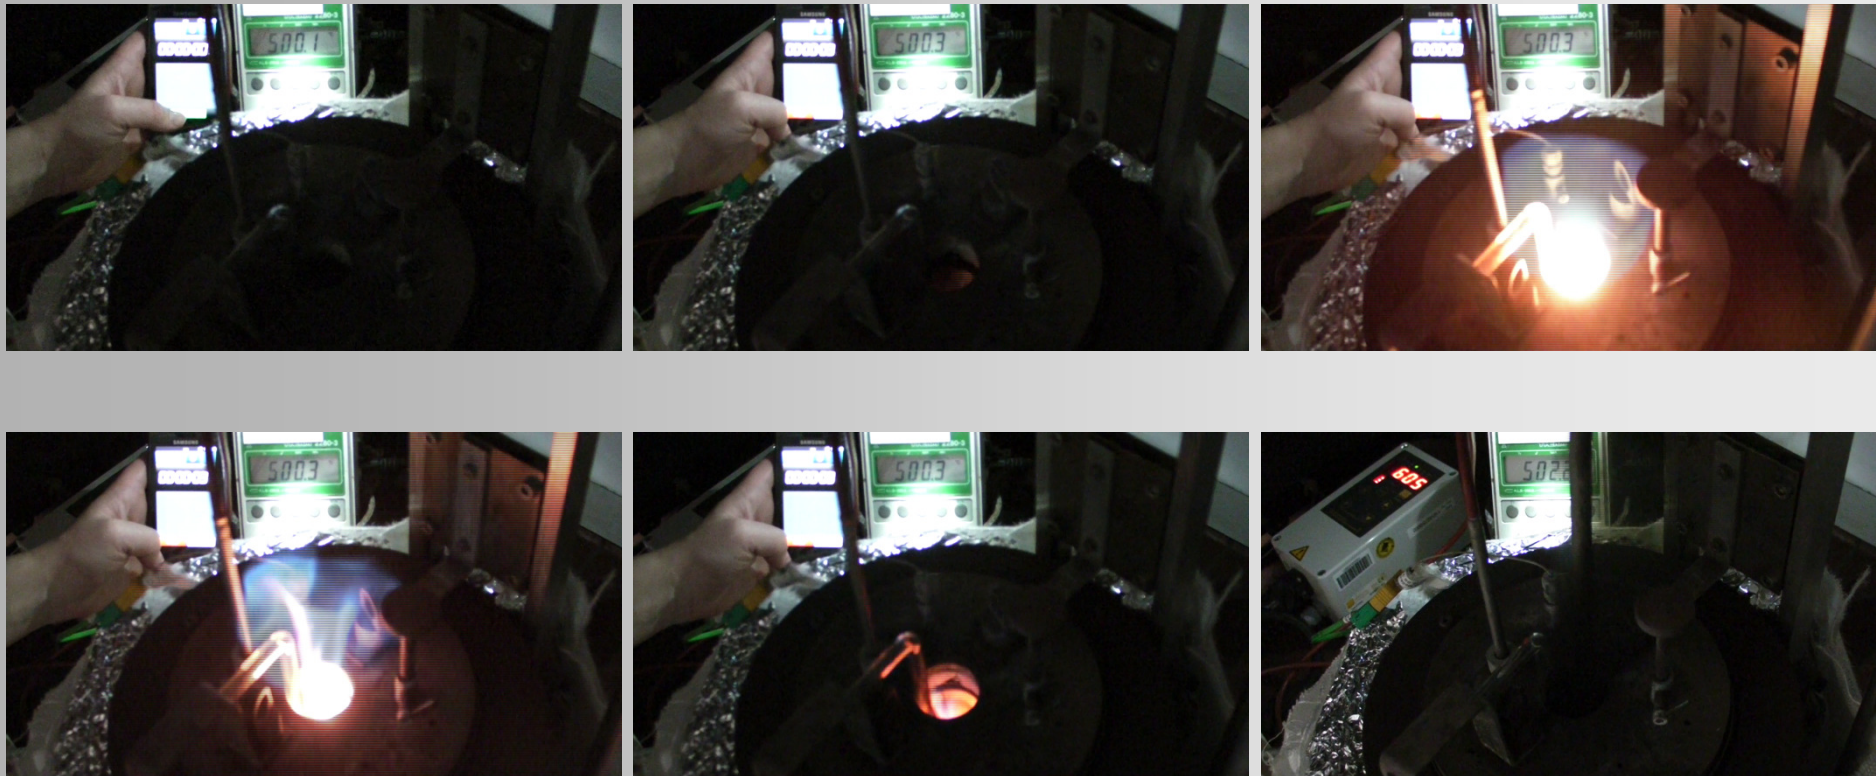
Test at 500 °C (IDT = 4 s)

Spülvorgang mit Druckluft (Ruß)

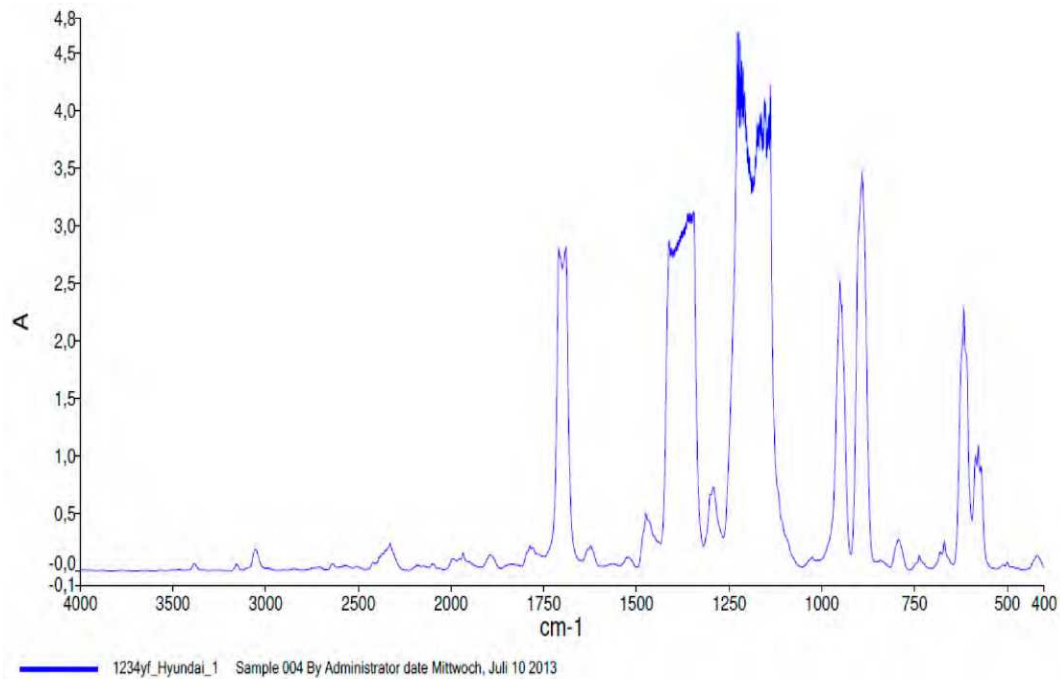
Figure 3: FT-IR spectrum of 2,3,3,3-tetrafluoroprop-1-ene (R1234yf); gas sample from the service interface of the Hyundai i30's air conditioning system after a leak test, taken in a 20 mm gas cell.

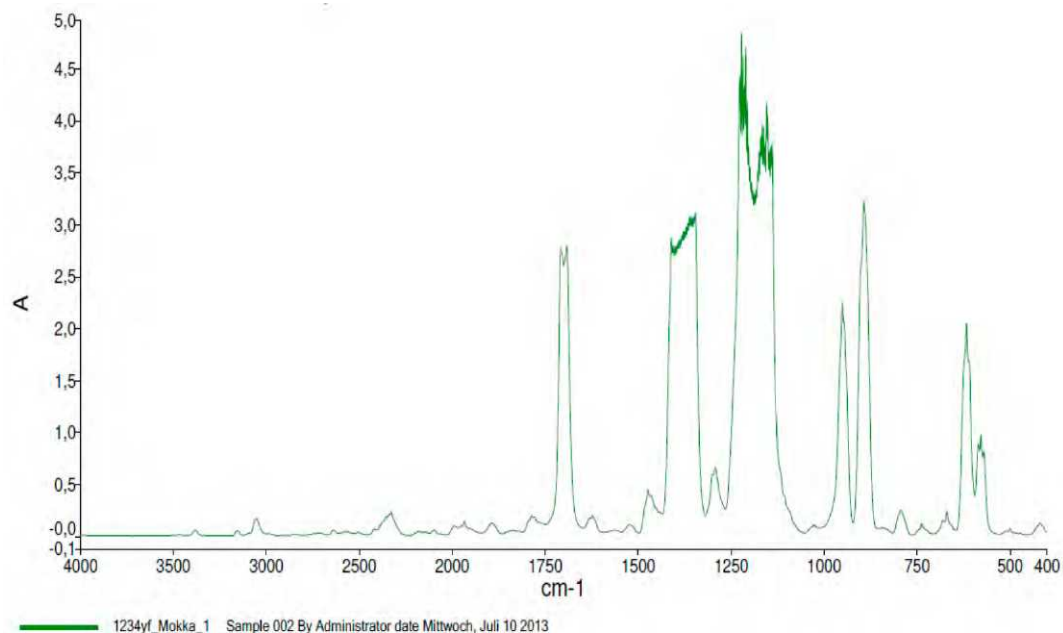
Figure 4: FT-IR spectrum of 2,3,3,3-tetrafluoroprop-1-ene (R1234yf); gas sample from the service interface of the Opel Mokka's air conditioning system after a leak test, taken in a 20 mm gas cell.

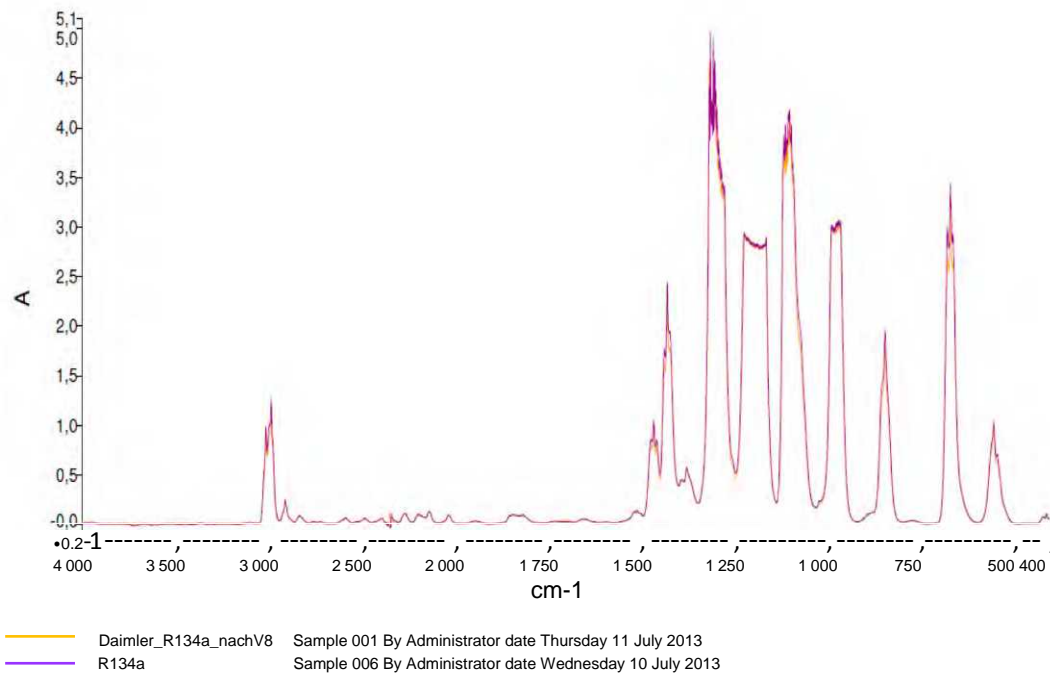
Ignition of R1234yf was observed in a leak test with a car, so the air conditioning system was filled with R134a for a final test. After the leak test, once again a gas sample was taken via the car's air conditioning service interface and compared to the absorption spectrum of pure R134a. The result is illustrated in Figure 6. No deviations were visible, so it is assumed that the car's air conditioning system was filled cleanly with R134a without any residue of R1234yf. In this case, again, under these conditions, no oil fractions were included in the sampling.

Figure 6: FT-IR spectrum of 1,1,1,2-tetrafluoroethane (R134a) ); gas sample from the service interface of the Daimler B-Class air conditioning system after a leak test using R134a and from the automatic air conditioning service station, each taken in a 20 mm gas cell
