Indoor air quality after installation of building products in energy- efficient buildings

Final Report

Project No. (FKZ) 3711 62 204
Report No. (UBA-FB) 002272/ENG

Prof. Dr.-Ing. habil. Birgit Müller, Dipl.-Ing. Alexander Mertes
Hochschule für Technik und Wirtschaft Berlin (HTW), Berlin

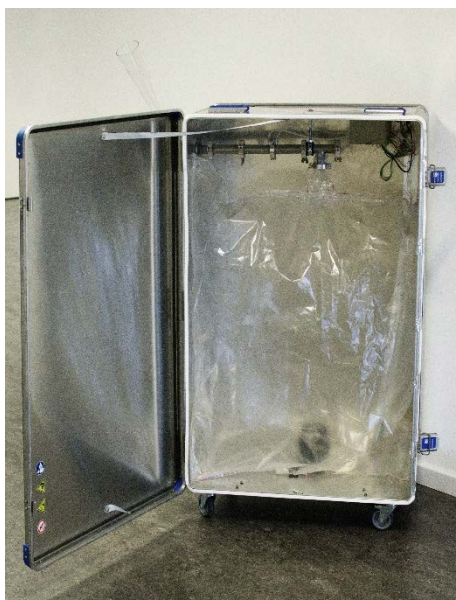
Figure 4: AirProbe and sample container

The "AirProbe" sampling and sample provision system developed within a thesis (Müller 2002) was used for room air sampling. Its purpose is to fill and empty sample containers made from Tedlar® (see Figures 3 and 4). The problem with fans is that they can change the air sample due to their own emissions or emissions from lubricants. Adsorption or desorption processes can occur within the fans or on the walls of the connecting pipes, which may influence the air sample composition. Therefore, no fans have been installed in the sample air pathway in the AirProbe system, and the supply and discharge pipes have been kept short. Air transport is produced by two fans integrated into the housing. One fan produces a vacuum, the other one generates pressure, and accordingly, the first one fills and the second one empties the sample container without getting into direct contact with the air. The sampling container is attached to a short stainless steel tube in the housing and the sample air is transferred to the sample container. When samples are needed, air is transported in the opposite direction to the outside. The following figures show the AirProbe system's principle sketch (Figure 3) and the opened AirProbe with the Tedlar® sample container installed (Figure 4).

The sample containers used have a dimension of 100x100x30 mm and a corresponding volume of about 300 litres. Previous studies have shown that this volume is sufficient to carry out a test run by 12 panellists. In order not to influence the sample air, the containers are heated at approx. 80 °C before and after use for several hours. A constant air flow rate of 0.9 l/s (± 0.1 l/s) is provided for air sample provision.

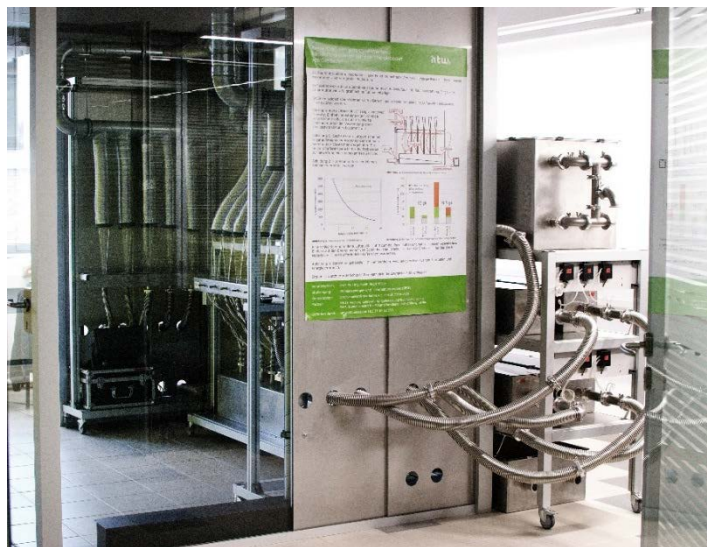
Figure 5: AQ laboratory of HTW Berlin

The sensory tests were carried out in the air quality laboratory (AQ laboratory) of HTW Berlin. The laboratory consists of a test cubicle where the panellists perform their assessments, plus a cabin where the panellists can stay between assessments for their sense of smell to recover. Both cabins are supplied by a special low-odour air conditioning system. A slight pressure in the cabins prevents ambient air from entering the cabins. The materials used for components in contact with air are glass and stainless steel. Both odour emission and adsorption of substances in these materials is low. Odour-laden air from the emission chambers is conveyed through stainless steel pipes to the assessment cabins and led to a glass funnel where the panellists perform their odour assessment. The sample to be assessed is not visible to the panellists.

The following Figure 5 shows the AQ laboratory: the chamber with the comparative scale is on the left and the CLIMPAQ emission chambers are on the right. Figure 6 shows an emission chamber (CLIMPAQ) loaded with a textile floor covering.

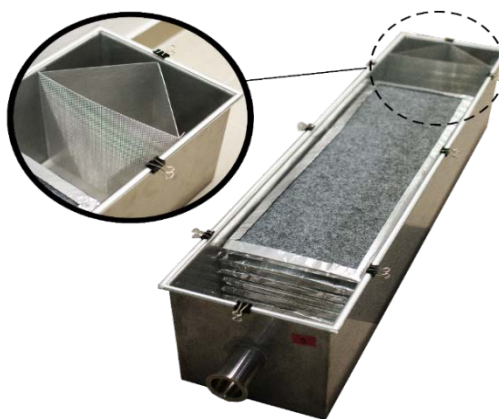
Figure 6: CLIMPAQ

Indoor materials to be tested for odour assessment are placed in a glass and stainless steel emission chamber (CLIMPAQ) for 28 days and a constant flow rate of low-odour air is allowed to flow around them. The term CLIMPAQ is an acronym of "Chamber for Laboratory Investigations of Materials, Pollution and Air Quality". The chambers meet the DIN EN ISO 16000-9 requirements and are optimised for the tests being carried out. (ISO 16000-9 2008)

Glass plates measuring 20 cm x 65 cm have been used as carriers for viscous materials (plasters, adhesives, paints). Solid materials (plate materials or insulating materials) can be placed directly into the chambers. The edges are covered by an odour-neutral aluminium adhesive tape to ensure that only the material surface is exposed to the air flow.

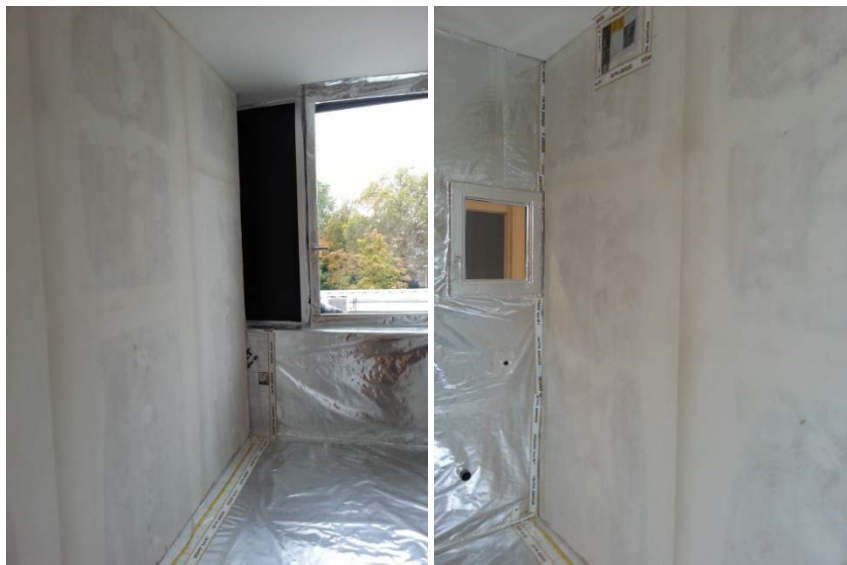
Figure 36: Photos of wall assembly 1 (Kühn 2013)

First, the primary insulation layer was applied and fastened to the wall underneath using a few screws. Metal studs were subsequently fastened to the ceiling and floor in a way that enabled the second installation to be mounted approximately 10 mm away from the first insulation layer. The vapour barrier film was applied to overlap on all sides and was secured tightly with adhesive tape. The plasterboards were screwed on and finally filled with putty over the entire surface. The components that were not examined were completely covered with odourless film to minimise their influence on the results. Figure 36 below shows images of the introduced assembly in the test room.

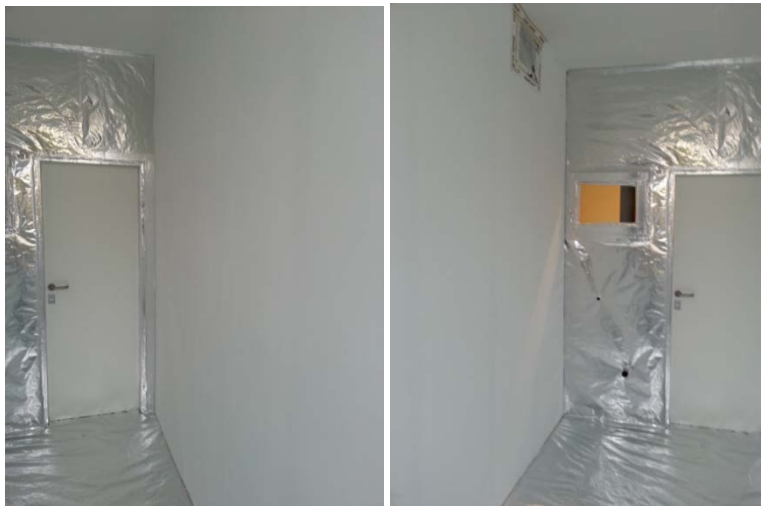
Figure 37: Photos of wall assembly 2 (Kühn 2013)

The composite boards were applied to the wall using individual adhesive points (special adhesive). Since the substrate (aluminium composite film) was not load-bearing, the composite boards were additionally fixed to the substrate with a few screws. After drying overnight, putty was then applied to the entire surface and painted with deep penetrating primer. Following a short drying time, two coats of interior silicate paint were applied. The components that were not examined were completely covered with odourless film to minimise their influence on the results. (Figure 37)

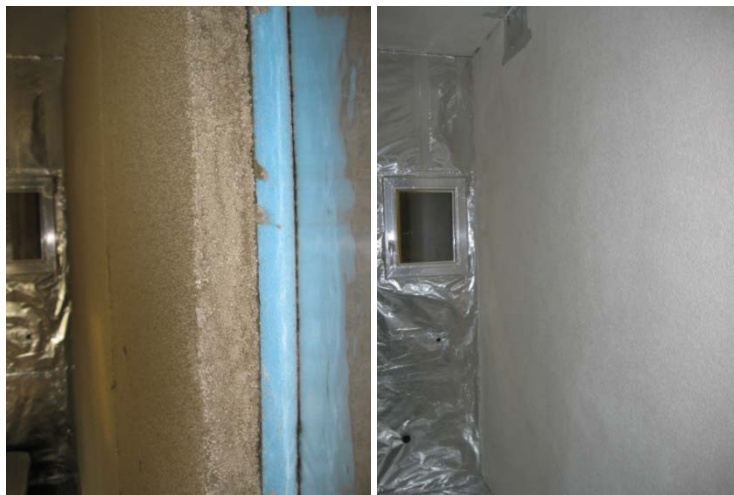
Figure 39: Photos of wall assembly 4 (Kühn 2013)

The prefabricated spray plaster insulation boards were screwed to the wall underneath, followed by the application of coarse-meshed reinforcing fabric with adhesive and basecoat mortar. Universal primer was applied after drying and covered with a float finish. The components that were not examined were completely covered with odourless film to minimise their influence on the results.

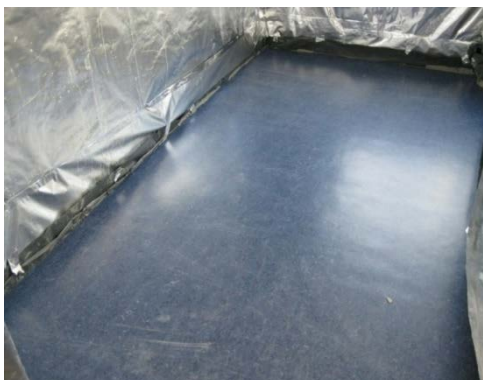
Figure 40: Photo of floor assembly 1 (Kühn 2013)

Floor assembly 1 manufactured in the test room consisted of the following products:

- ▶ Screed element
- ▶ Thin screed
- ▶ Linoleum covering

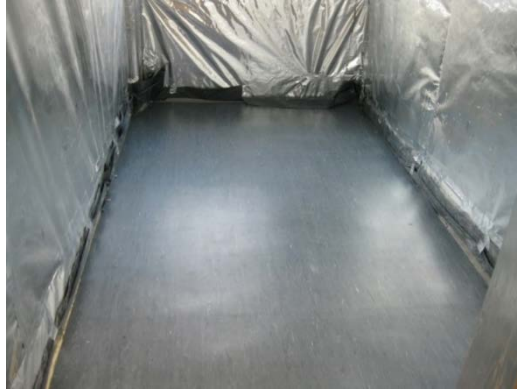
Figure 41: Photo of floor assembly 2 (Kühn 2013)

Floor assembly 2 was composed of the following materials:

- ▶ Screed element
- ▶ Wood levelling compound
- ▶ Carpet/linoleum adhesive
- ▶ PVC design covering

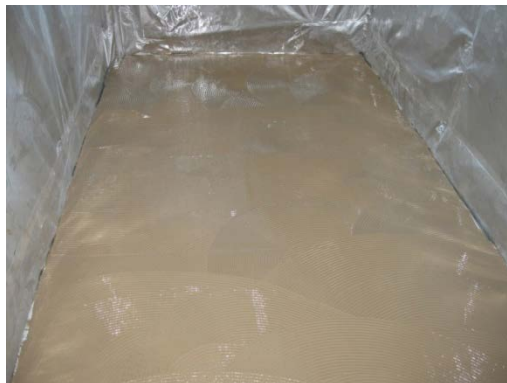
Figure 42: Photo of floor assembly 3 (Kühn 2013)

Floor assembly 3 was a multi-layered assembly consisting of the following components:

The following image shows the finished floor assembly in the test room.

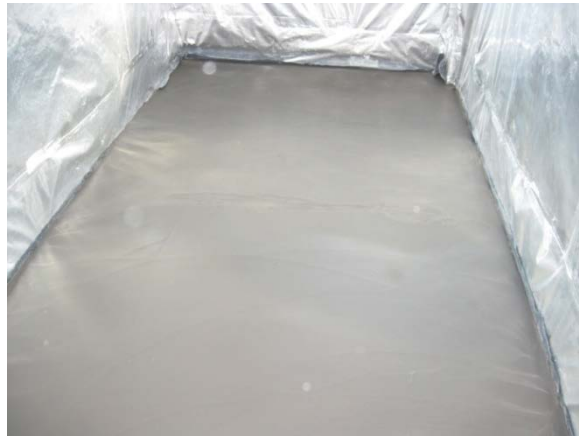
Figure 43: Photo of floor assembly 4 (Kühn 2013)

Floor assembly 4 was composed of the following products:

- ▶ Screed element
- ▶ Primer
- ▶ Design floor
