**Report on flammability and HF exposure trials with vehicle air conditioning systems using R1234yf**

1. Introduction

Under EU Directive 2006/40/EC, from 1 January 2011 new EC type-approvals may only use a refrigerant with a GWP (Global Warming Potential) value of less than 150 in passenger vehicle (M1) air conditioning systems. For EC type-approvals issued before 1 January 2011, the existing refrigerant R134a may continue to be used until the end of 2016.

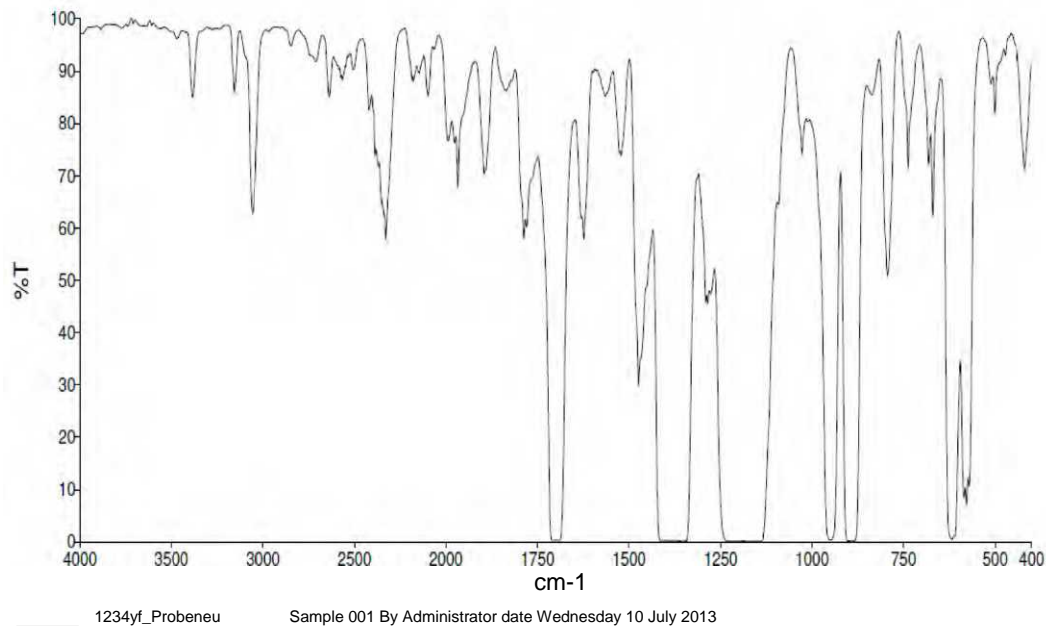
Figure 2: FT-IR spectrum of 2,3,3,3-tetrafluoroprop-1-ene (R1234yf); gas sample from the gas cylinder for refilling the service station, taken in a 20 mm gas cell

Figure 2 shows the FT-IR spectrum of R1234yf recorded, shortly before the automatic air conditioning service station gas cylinder was refilled, in a 20 mm gas cell using a Perkin Elmer Spectrum Two IR Spectrometer. It was not possible definitively to dilute the gas extracted from the gas cylinder, so the refrigerant was analysed pure. This resulted in overloading of the signals in various wave number ranges. Nevertheless, the characteristic peaks of R1234yf were clearly identifiable. The peaks on the baseline which were not very distinct in the reference spectrum were much more pronounced in the sample spectrum. There was no indication of peaks attributable to possible contamination.

Thus, it was guaranteed that all further refills of the car air conditioning systems from the refilled automatic air conditioning service station could continue to be filled with R1234yf as normal.

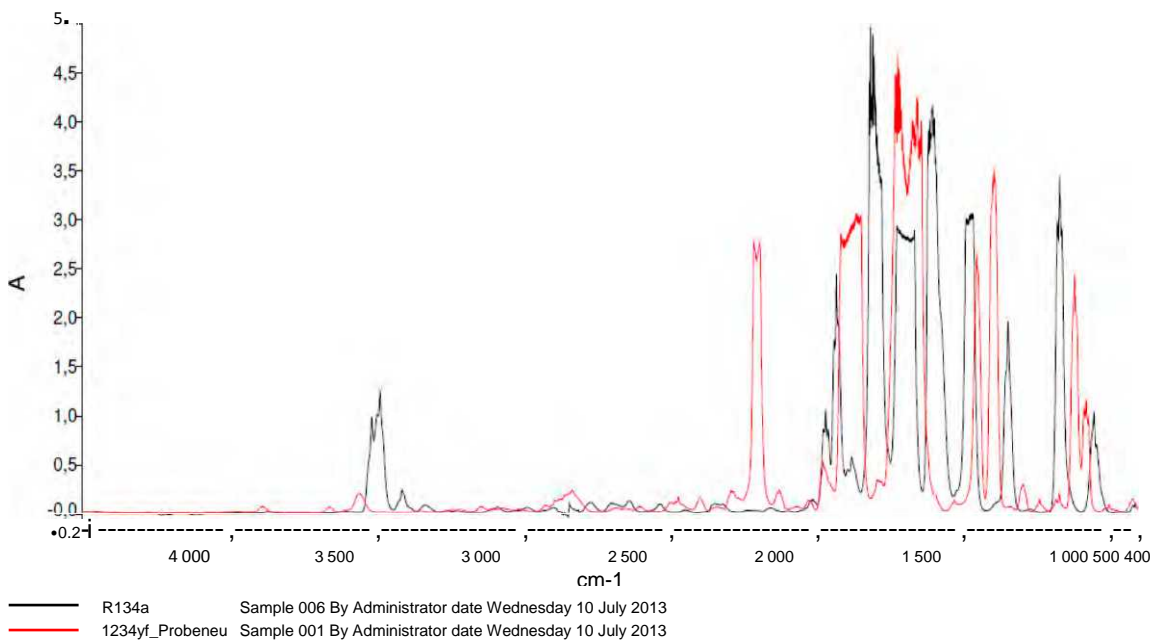
Figure 5: FT-IR spectrum of 2,3,3,3-tetrafluoroprop-1-ene and 1,1,1,2-tetrafluoroethane (R134a) respectively, each taken in a 20 mm gas cell

Distinct differences emerge between the two spectra. The biggest differences are the individual peak for R134a at a wave number of  $3\,000\text{ cm}^{-1}$  and the isolated peak for R1234yf at a wave number of  $1\,700\text{ cm}^{-1}$ .

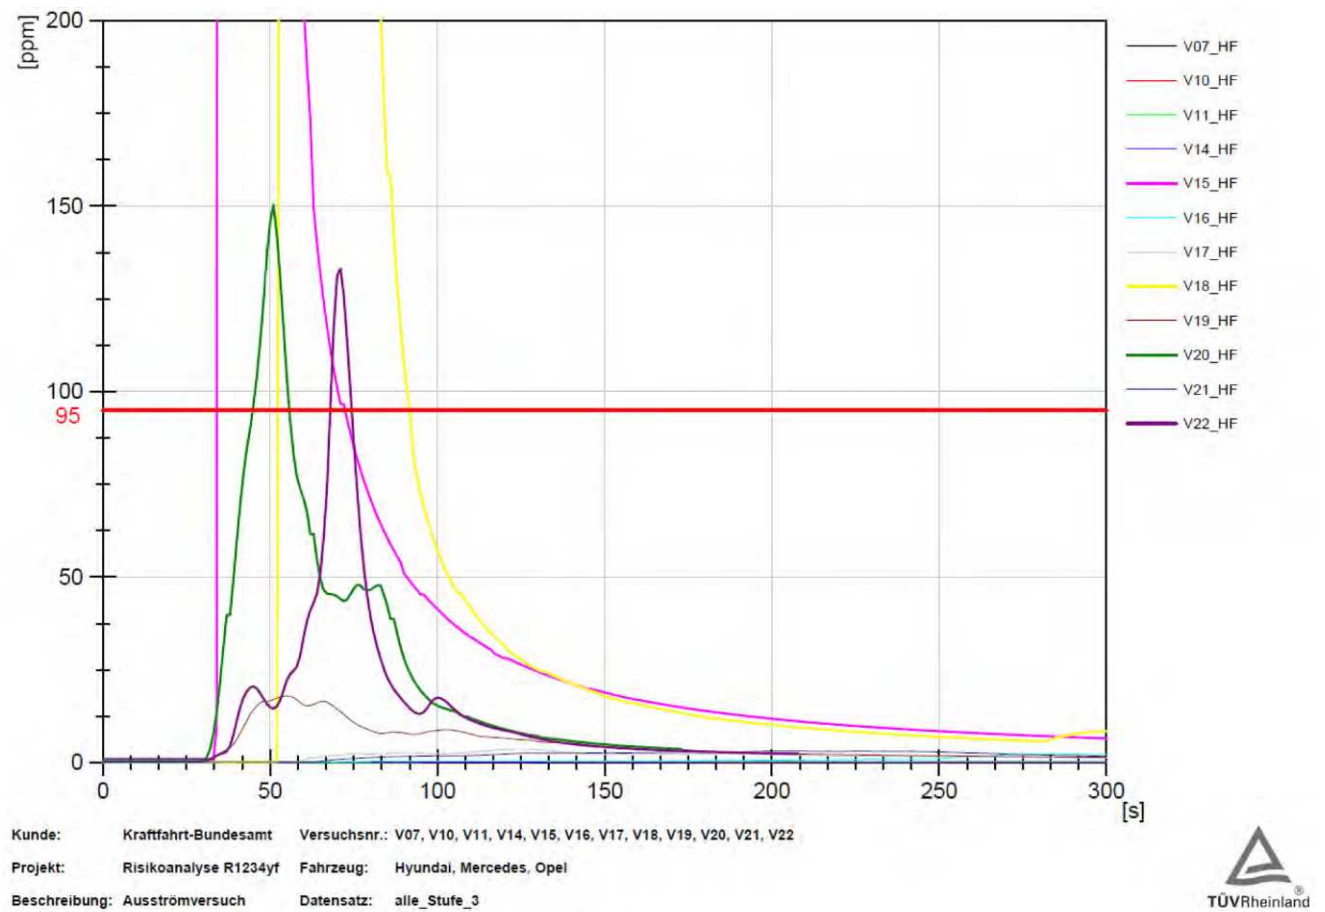
**Figure 1: First measurement sheet provided by KBA**

The measurement data was initially provided in the form of a measurement sheet showing a number of HF measurement graphs (see Figure 1 in the Annex).

■ Concentrations < 0.5 ppm HF, as measured in Tests 1–14, do not raise any expectation of damage to health.

■ In Tests 16, 17, 19 and 21, HF concentrations in the range of 2.4 to 18 ppm were obtained, for which the occurrence of slight, reversible irritation of the respiratory passages, skin and eyes — i.e. not associated with any permanent damage to tissue — is probable.

■ In Tests 20 and 22, HF concentrations were obtained from which severe, irreversible damage [severe irritation or chemical burns to the respiratory tract with possible tissue destruction (formation of necroses) and restriction of lung function, chemical burns to skin and eyes] is probable.

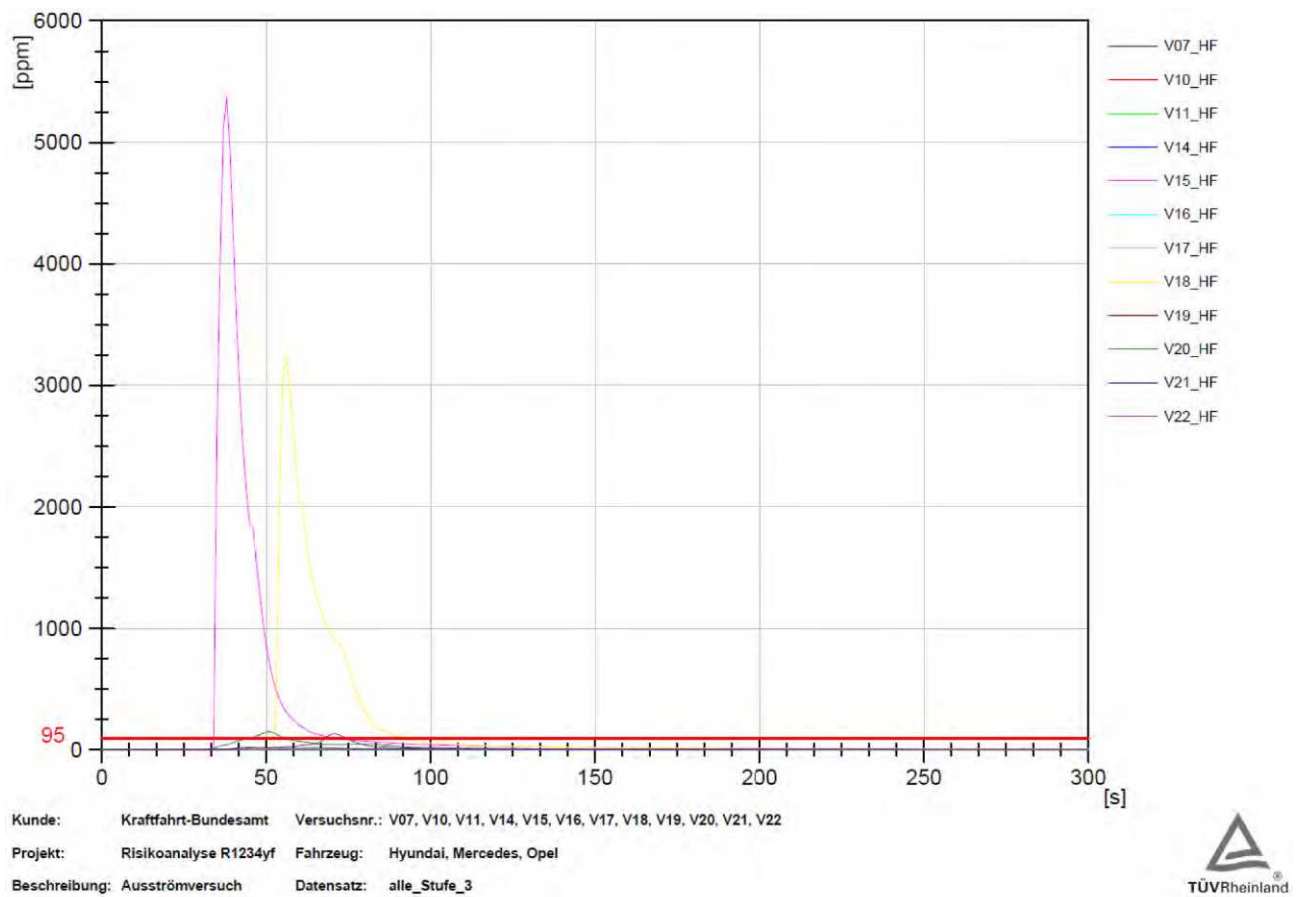
**Figure 2: Second measurement sheet provided by KBA**

On 11 September 2013, BfR, after consulting the Federal Office for Chemicals (BfC), telephoned its contact at KBA in order to clarify some unresolved questions. Following on from this conversation, KBA sent another two measurement graphs (Figures 2 and 3 in the Annex), and a table showing the peak concentrations determined (Table 2 in the Annex) directly to BfR.
