# Tailings Management Facilities (TMF) Safety Methodology

TEXTE 114/2023

Project: "Improving the safety of tailings management  
facilities in Kyrgyzstan"

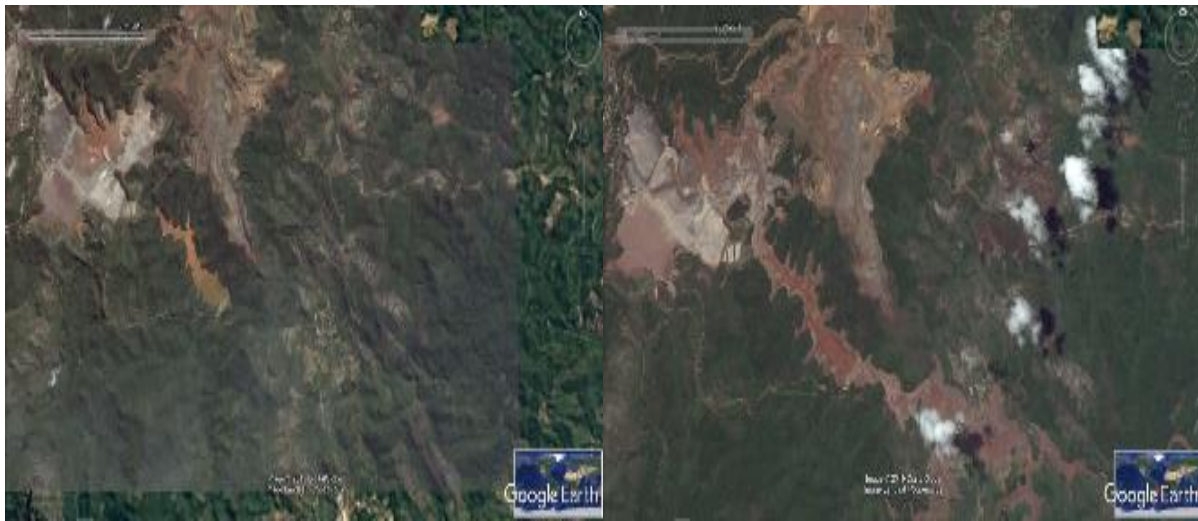
However, the image analysis of the accident (13) shows that the distance to the affected main waterbody is less than 1 km.

**Figure 13. Territory near the Fundão dam on 21.07.2015 (left) and 11.10.2015 (right).**

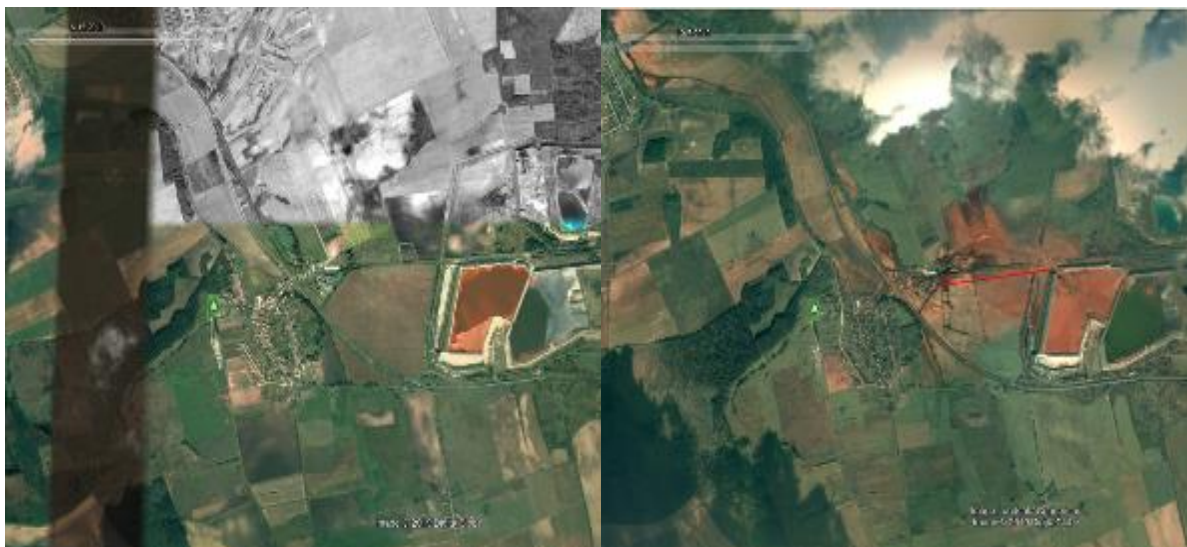
During a disaster near Ajka, the red mud reached the municipalities of Devecser, Kolontár, Somlóvásárhely, Somlójenő, Tüskevár, Apácatorna and Kisberzsény. An area of about 8 km<sup>2</sup> was flooded. In the following days, the red mud contaminated the Torna creek and the valley of river Marcal, almost reaching the river Rába. Through the Torna, Marcal, Rába and the Moson branch of the Danube, the alkaline red slurry travelled about 80 kilometres downstream and finally entered the Danube River. The image analysis (Figure 14) shows that the distance to the nearest settlement and surface water that were contaminated with the released tailings is about 4 km.

**Figure 14. Territory near the Ajka TMF on 07.10.2010 (left) and 22.10.2010 (right).**
