Safety of the Tailings Management Facilities in the Danube River Basin

Technical Report

Capacity development to improve safety conditions of tailings
management facilities in the Danube River Basin – Phase I:
North-Eastern Danube countries (Danube TMF project)

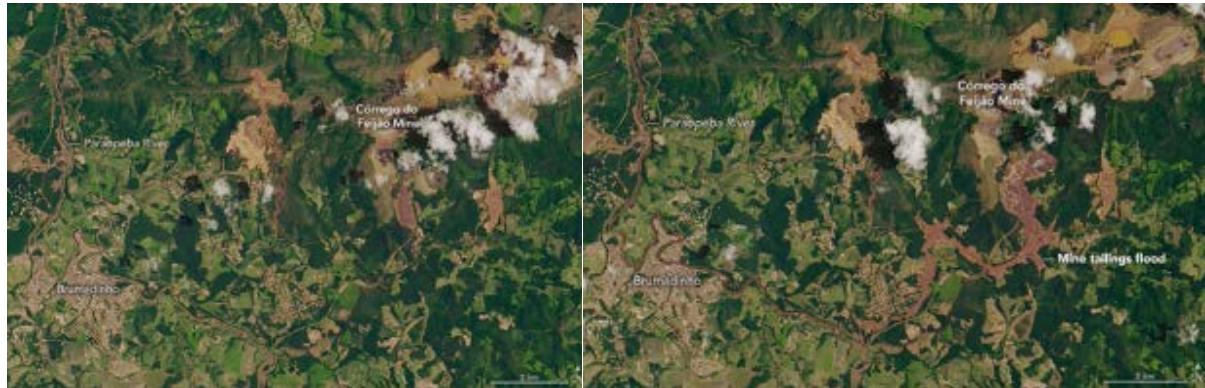
Figure 6. Territory near the Córrego de Feijão dam on 14.01.2019 (left) and 30.01.2019 (right).

Paraopeba. The mud first hit the mine administrative area and a small community about 1 km downstream of the mine. The National Water Agency stated that the tailings had polluted over 500 km of rivers. The image analysis shows that the downhill runout distance was approximately 7 km after that the plume reached the river (Figure 6).

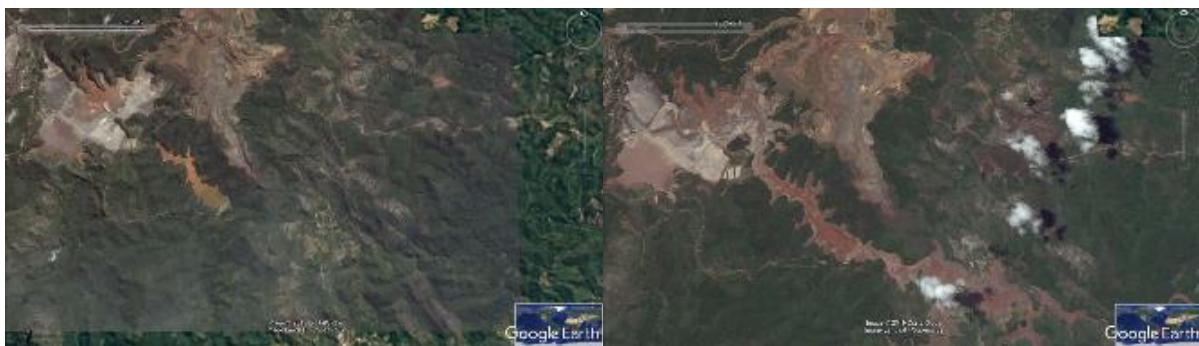
Figure 7. Territory near the Fundão dam on 21.07.2015 (left) and 11.10.2015 (right).

The failure on the Samarco Mineração S.A Fundão tailings dam on the 5th of November 2015 released tailings, which travelled downstream via a natural waterway. The mud continued to move further about 650 km along the Rio Doce River, reaching the Atlantic coast 17 days later. However, the image analysis of the accident (Figure 7) shows that the distance to the affected main waterbody is less than 1 km.

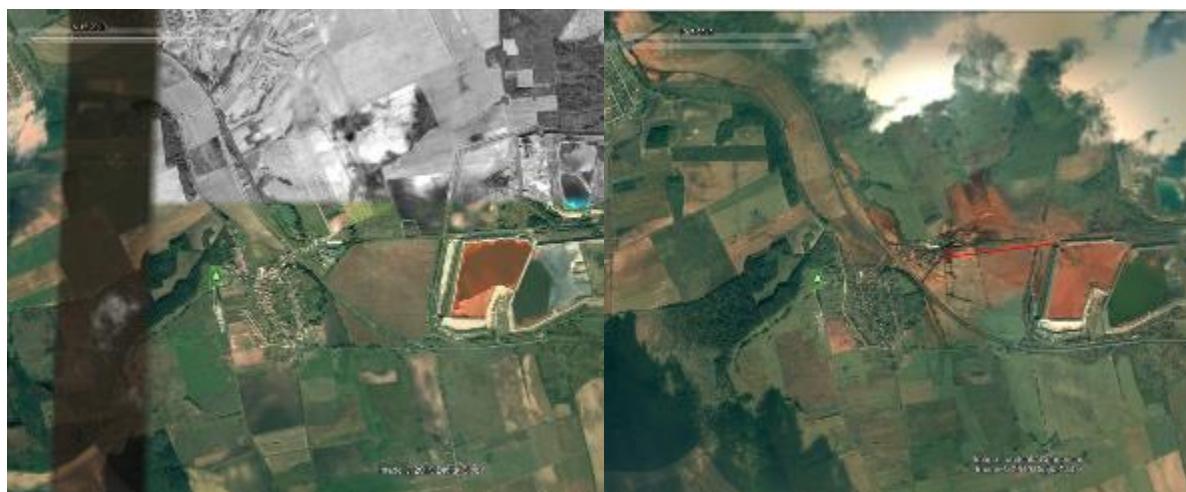
Figure 8. Territory near the Ajka TMF on 07.10.2010 (left) and 22.10.2010 (right).

During a disaster near Ajka, the red mud reached the municipalities of Devencser, Kolontár, Somlóvásárhely, Somlójenő, Tüskevár, Apácatorna and Kisberzsény. An area of about 8 km² was flooded. In the following days, the red mud contaminated the Torna creek and the valley of river Marcal, almost reaching the river Rába. Through the Torna, Marcal, Rába and the Moson branch of the Danube, the alkaline red slurry travelled about 80 kilometres downstream and finally entered the Danube River. The image analysis (Figure 8) shows that the distance to the nearest settlement and surface water that were contaminated with the released tailings is about 4 km.
