BONUS CHANGE Recommendations towards Regulations for Sustainable Antifouling practices in the Baltic Sea

Preface

This set of five recommendations to Competent Authorities and marina operators across the Baltic Sea is a result of the 4-year project BONUS CHANGE – changing antifouling (AF) practices on leisure boats in the Baltic Sea. The recommendations are formulated both as a goal (Recommendation 1) and as practical recommendations that, if followed, would considerably reduce the current overuse of biocides, mainly copper, in marine AF paints used on leisure boats and as a result would lead to a much better situation for the environment in the sensitive coastal ecosystems of the Baltic Sea. The recommendations rest on BONUS CHANGE's scientific results that have shown that full protection of leisure boat hulls against biofouling can be achieved without using any biocides; the biocide, i.e., copper, content of AF paints can be reduced to one-seventh compared to the copper content in the most popular paints used by boaters, without renouncing AF performance; the present EU and national regulations can be used by Competent Authorities to achieve sustainable AF practices on leisure b

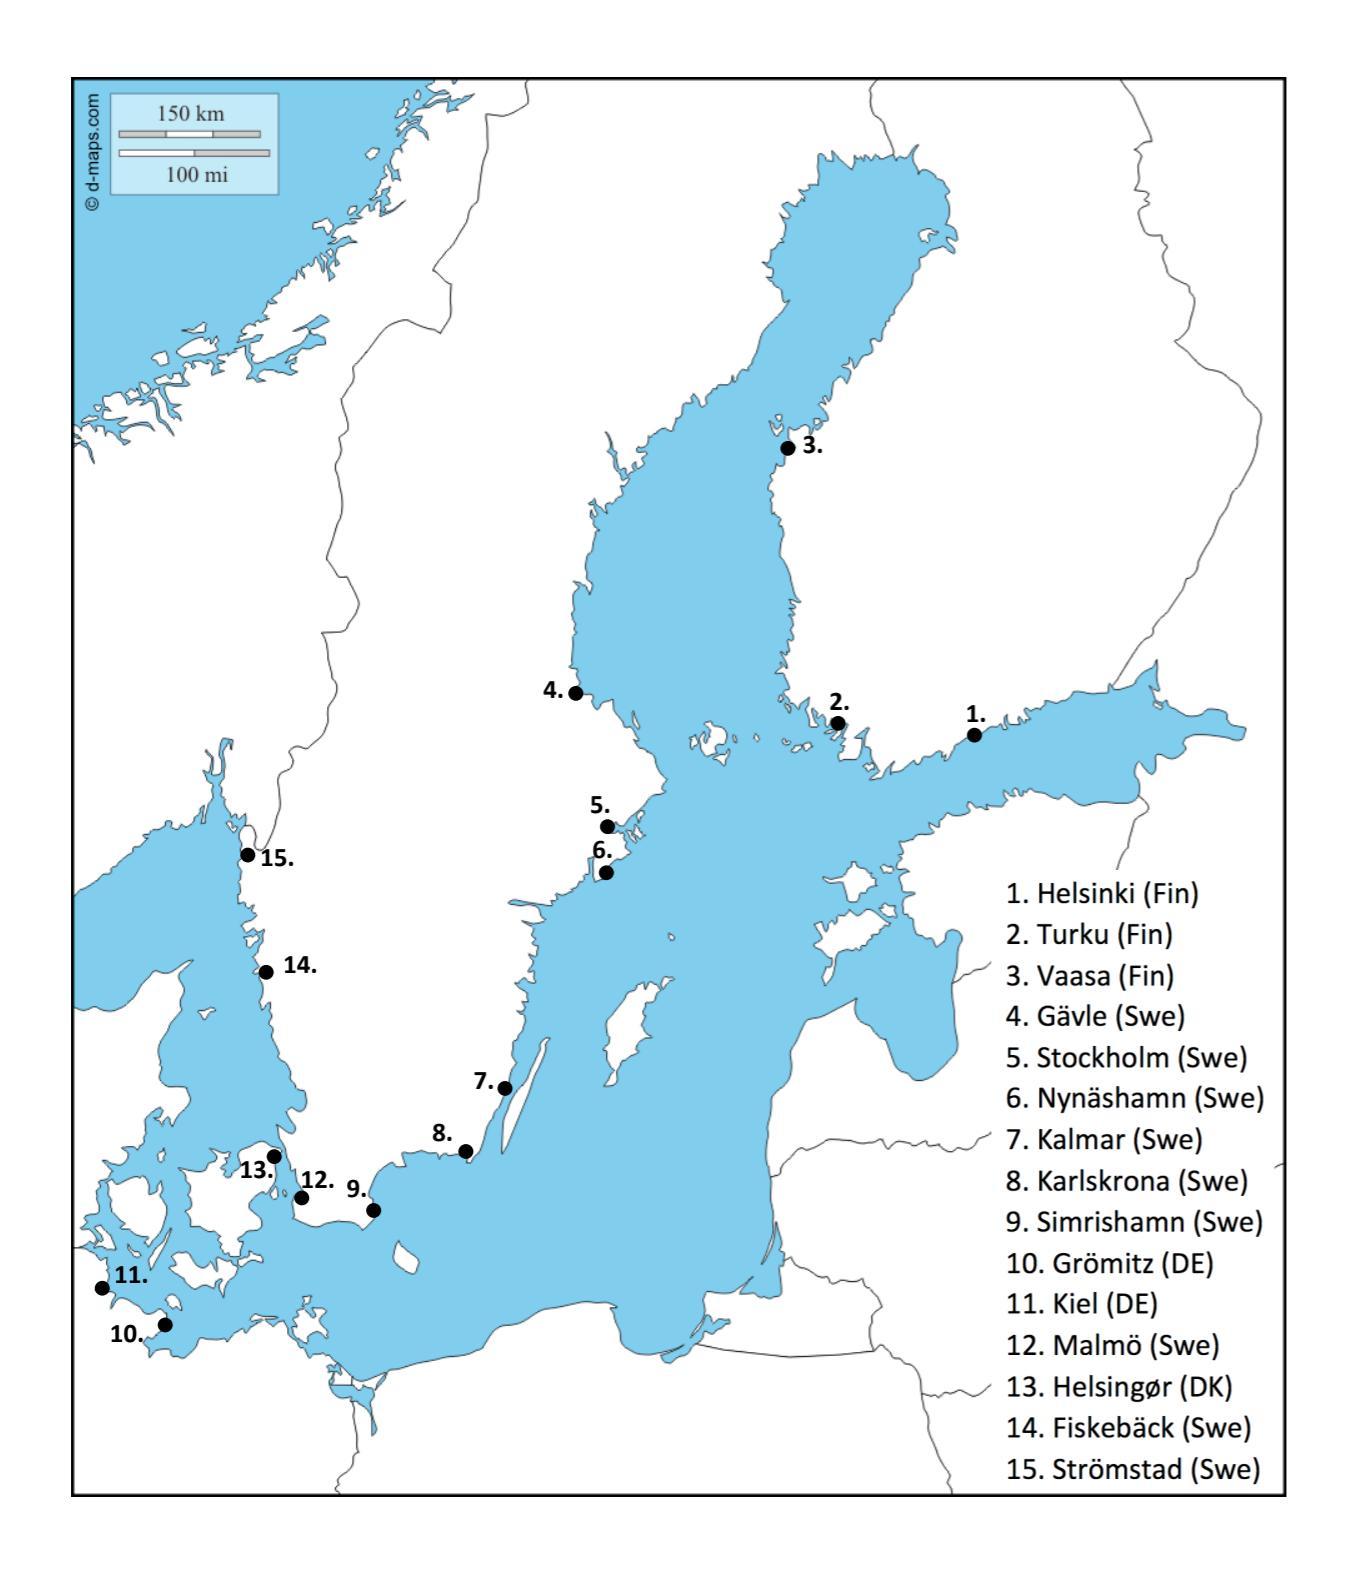
To evaluate the performance of different copper-based antifouling paints, panels were coated with paint and placed inside marinas at 15 locations around the Baltic Sea-Kattegat-Skagerrak (Figure 1).

The panels were submerged during May-October 2014-2016 and the fouling intensity (% coverage of panel) was evaluated after five months, at the end of the boating season. The static panels represent a 'worst-case' scenario; i.e. that the boat does not move during the whole season. The more the boat is used, the better the antifouling paint will perform, and the less the fouling will adhere. The evaluated paints are shown in the table below.

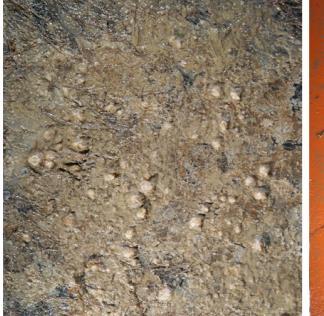
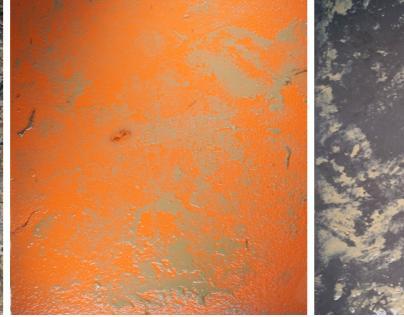
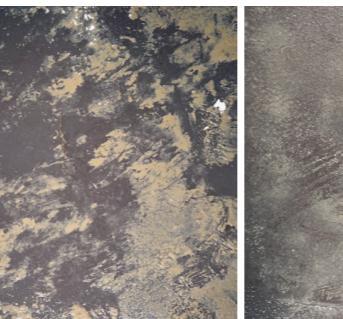
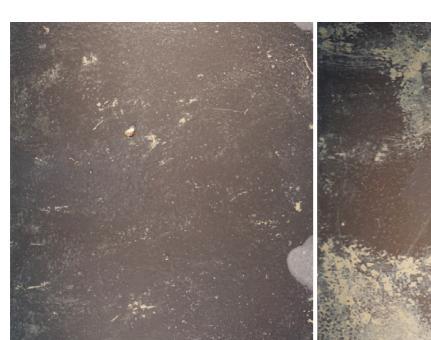
Photos of panels (Helsinki):

The fouling varies to some degree between years but consists mainly of bryozoans, hydroids and some barnacles (see Lago racing). All copper based paints were effective against fouling. Only biofilm and silt/clay was present on these panels. All copper-based paints were effective against fouling during two full boating seasons (5months x2) given that the coatings were gently cleaned between seasons). This shows that fouling protection can be achieved without re-painting each year.

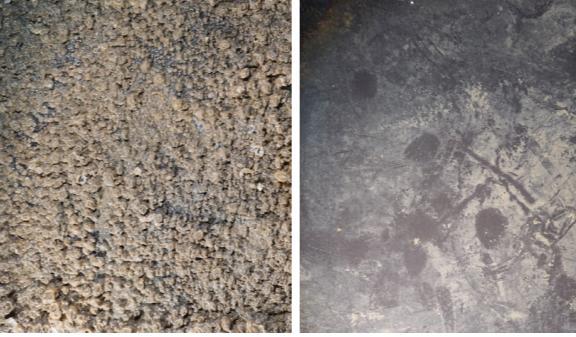
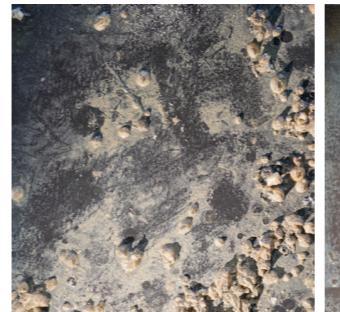
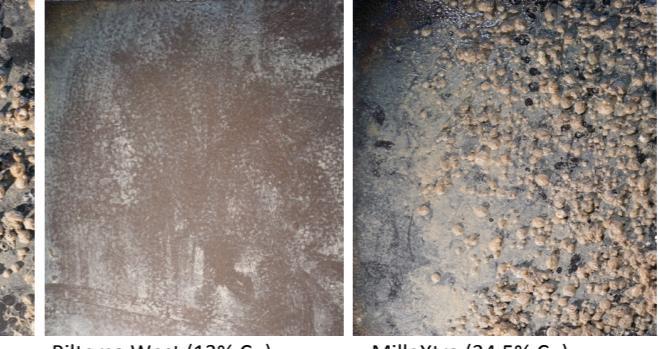
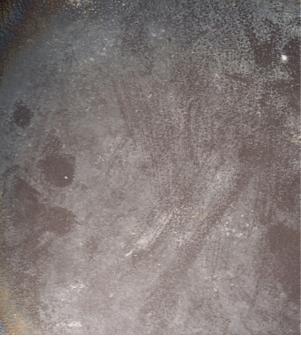
Photos of panels (Turku):

The fouling is strongly dominated by high intensities of barnacles. All except two of the copper based paints were efficient against barnacles (including the two with lowest copper content). The two paints that did not perform well (Cruiser One and Millextra) were still less fouled compared to the biocide-free paint. The reason for the low performance for these paints can, to some extent, be explained by the paint not being designed for low salinity environments, thus reducing the copper leakage from the paint and facilitating organisms to attach. However, other environmental factors may also have influenced these results.

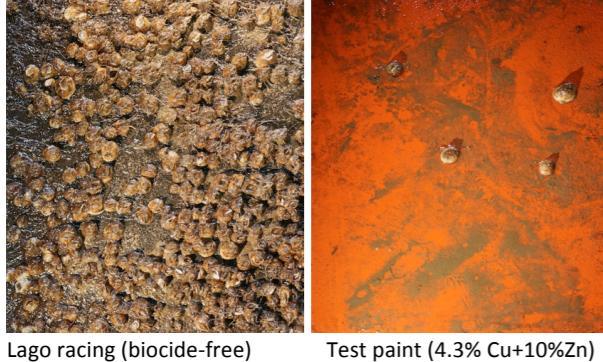
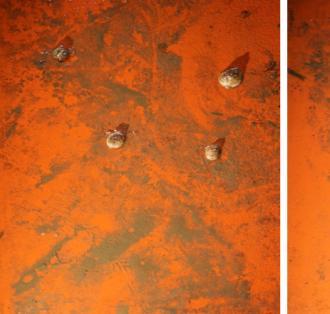
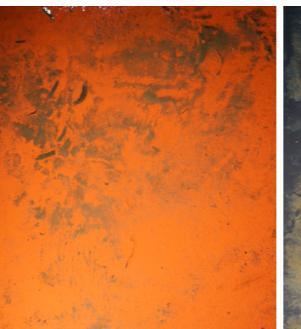
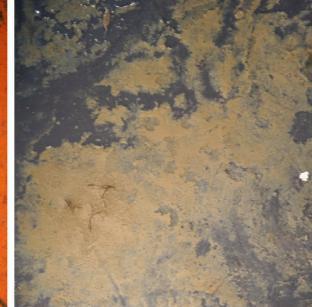
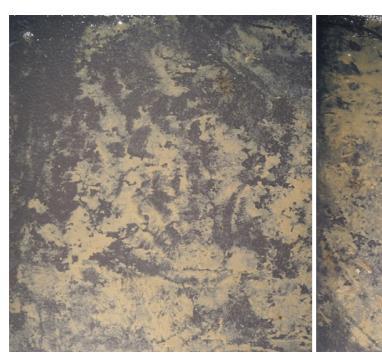
Photos of panels (Vaasa):

The fouling varies to some extent between years but consists of mainly barnacles and hydroids. Out of the commercial paints that were tested, all except one (Millextra with the highest copper content) were efficient against fouling. The can be explained by low salinity reducing the release rate of copper from the paint, which is designed for high salinities. The test paint containing 4% copper was 100% effective only when combined with 20% zinc, but showed relatively high performance also with lower zinc content (10%).

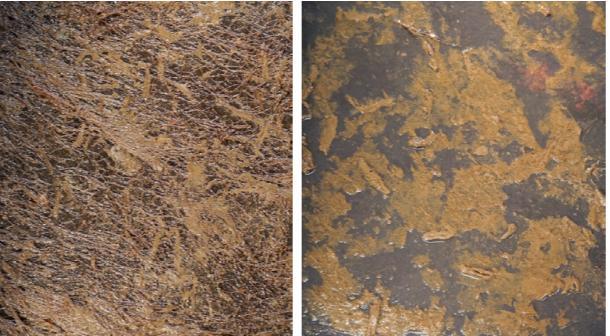
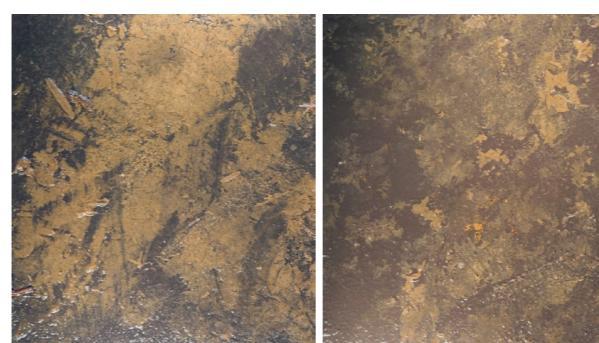
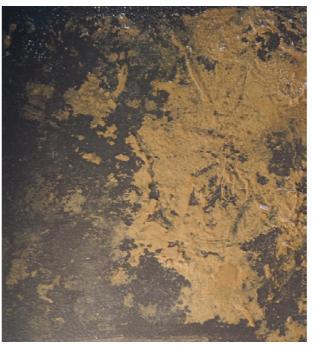
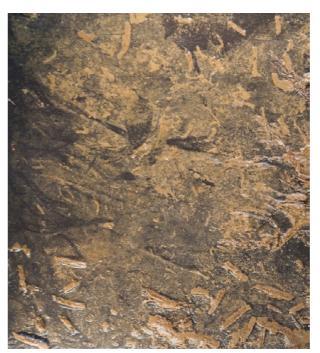
Photos of panels (Gävle):

The fouling was strongly dominated by hydroids. Barnacles (low coverage) only occurred during one out of three years. All copper paints were efficient against fouling. Only biofilm and silt was present on the panels painted with copper paints.

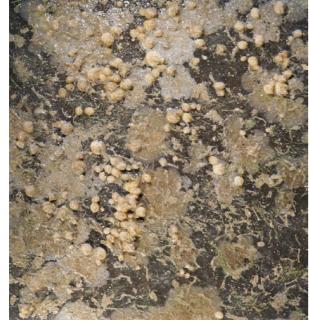
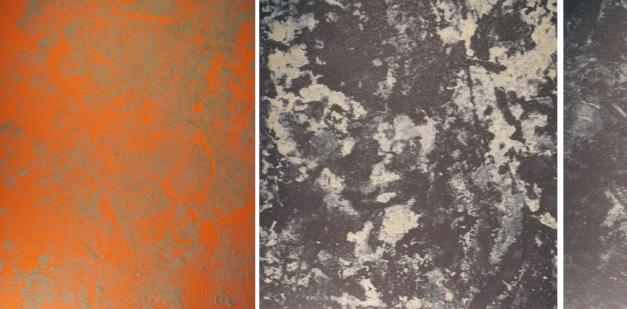
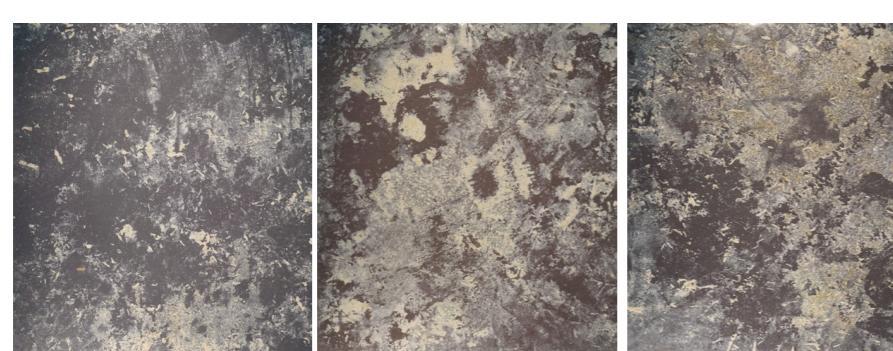
Photos of panels (Bullandö):

The fouling was dominated by barnacles and bryozoans. All paints containing copper (including 4.3% Cu) were highly effective against fouling, with only biofilm/silt present on the panels. All copper-based paints were effective against fouling during two full boating seasons (5 months x2) given that the coatings were gently cleaned between seasons). This shows that fouling protection can be achieved without re-painting each year.

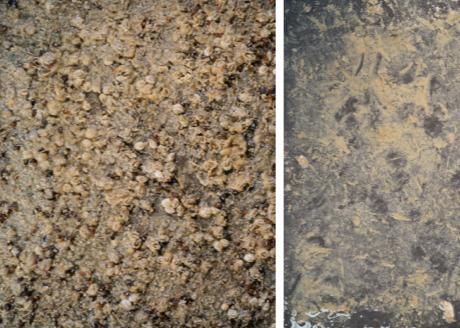
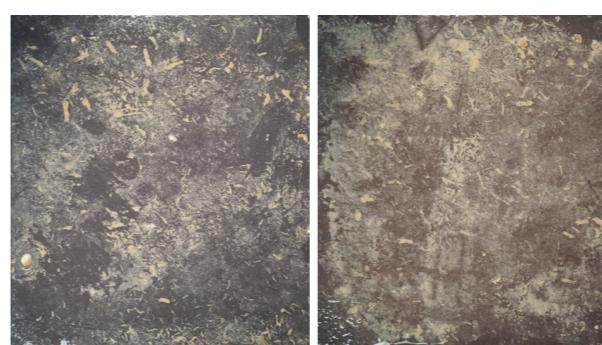
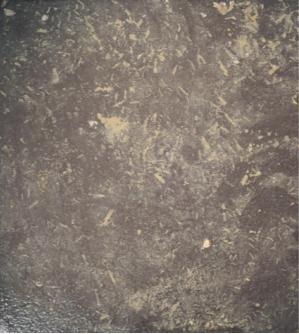
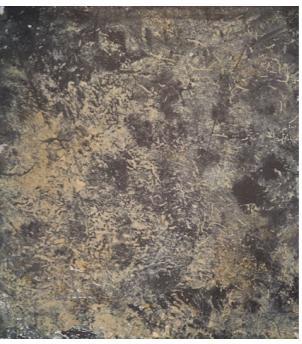
Photos of panels (Nynäshamn):

The fouling consisted mainly of barnacles and bryozoans, but mussels and hydroids did occur at low frequencies too. All copper-based paints were highly effective against fouling. Only biofilm and silt were present on the panels.

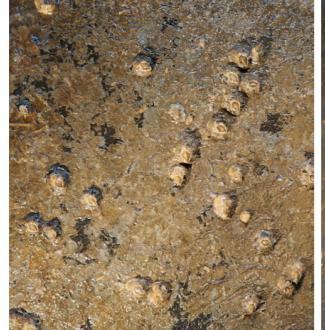
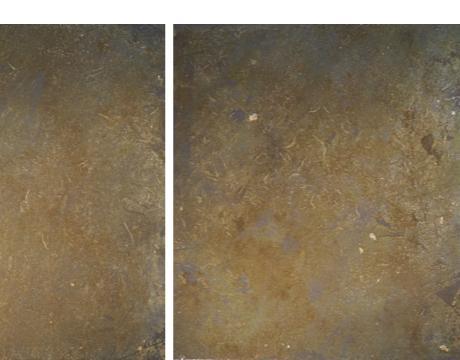
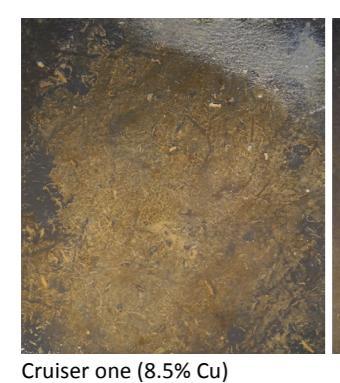
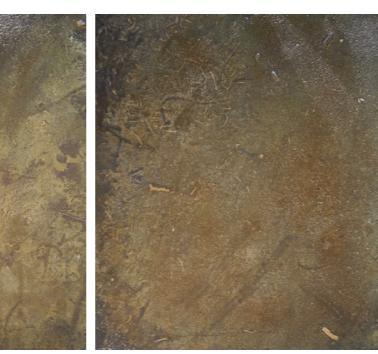
Photos of panels (Kalmar):

The fouling consists mainly of bryozoans, with some barnacles present at times. All copper-based paints were highly effective against fouling. Only biofilm was present on the panels.

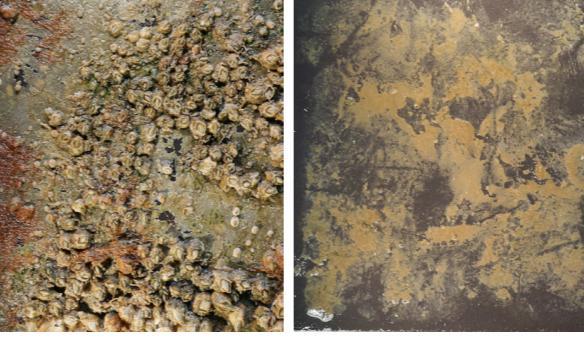
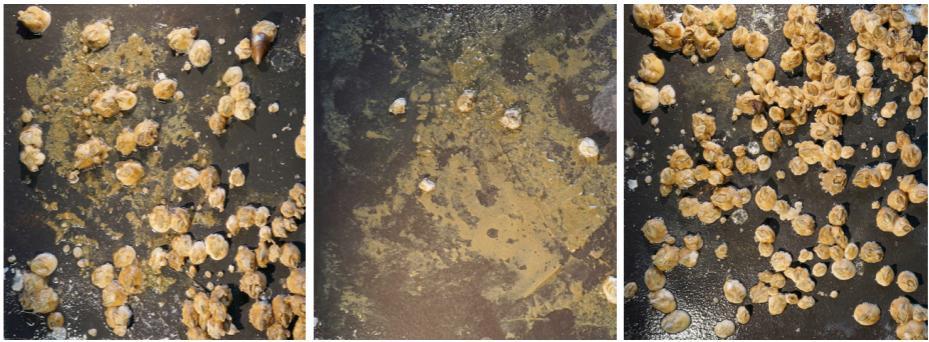
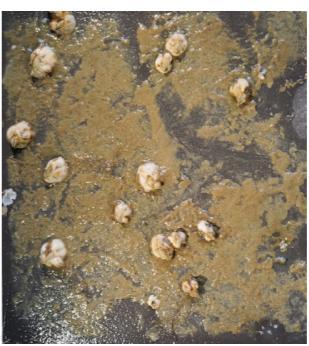
Photos of panels (Karlskrona):

The fouling consists mainly of barnacles, bryozoans and red filamentous algae. The only commercial paint that was 100% effective against macroscopic fouling was the MilleLight Cu (6.9%), highlighting the importance of total paint composition rather than only the amount of copper, for paint performance. Biltema West had only few barnacles present, whereas Cruiser One and MilleXtra had relatively high numbers. The larger size of the barnacles on the copper paints is most likely due to less competition for food and space on these panels, compared to the control panel. The results in Karlskrona can to some extent be explained by low salinity, but there are likely other factors that have not yet been clarified.

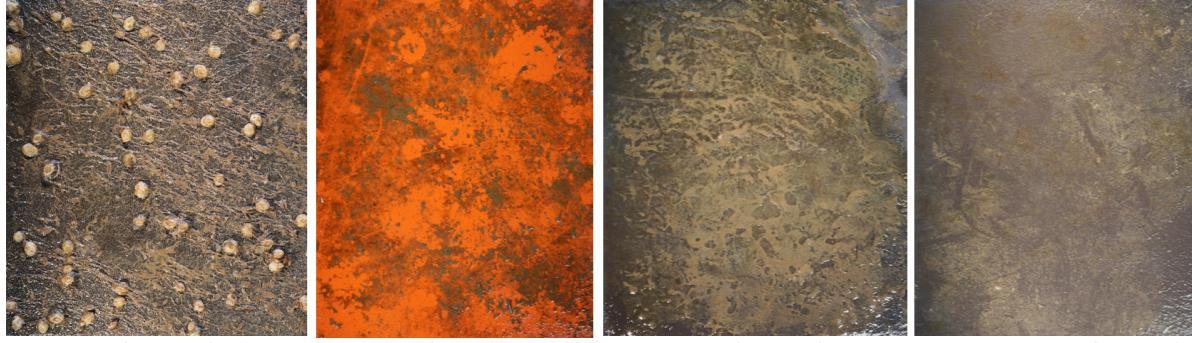
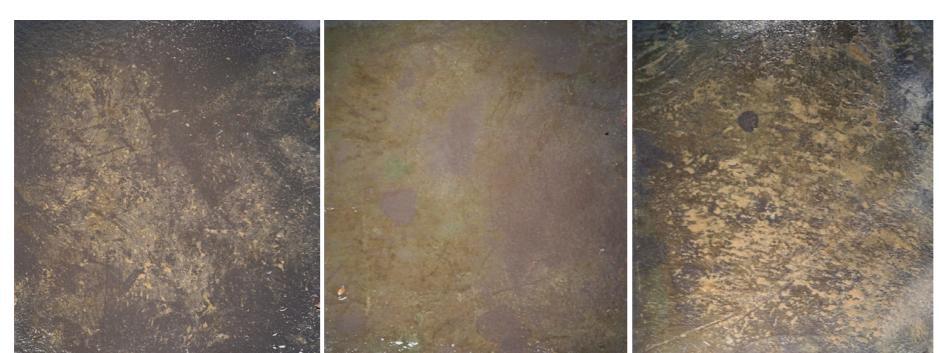
Photos of panels (Simrishamn):

Half of the fouling was barnacles each year, and the rest consisted of bryozoans, mussels and hydroids. All copper-based paints were highly effective against fouling. Only biofilm and silt were present on the panels.

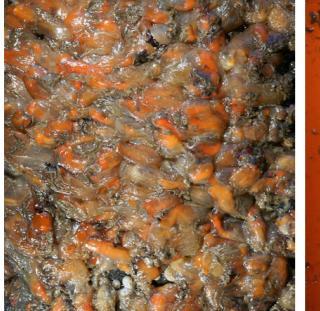
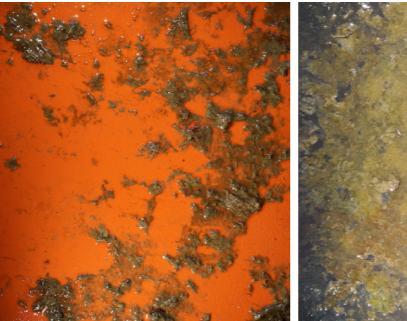
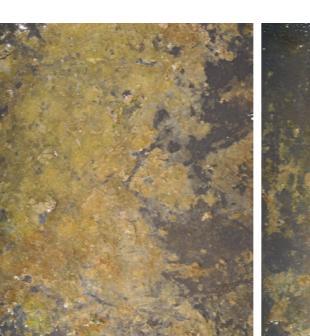
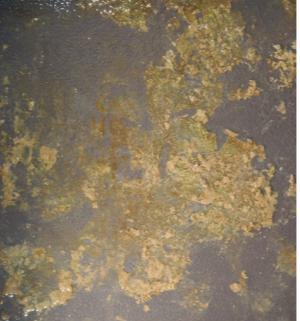
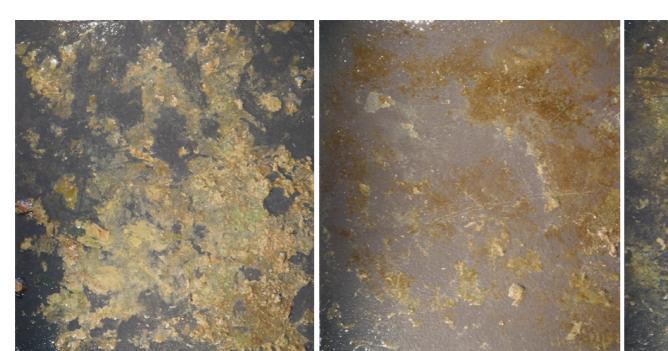
Photos of panels (Kiel):

The fouling was dominated by barnacles forming the bottom layer of fouling. On top, mussels and tunicates formed dense aggregates, which often seemed to have fallen off when too heavy, hence potentially reducing the total fouling coverage at the end of the boating season. Tunicates and mussels are more easily removed during vessel movements and thus may not be as problematic for boat owners as it may seem from the panels. All copper-based paints were highly effective against fouling. Only biofilm and silt were present on the panels.

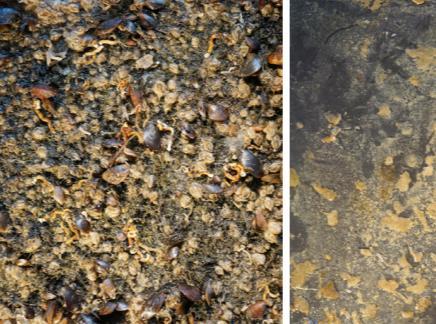
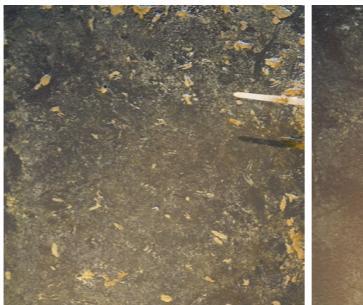
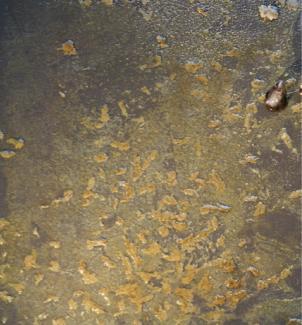
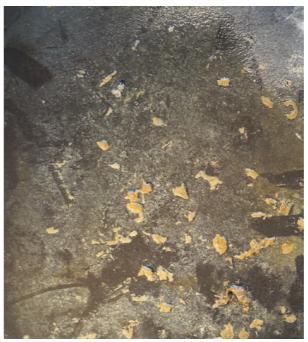
Photos of panels (Malmö):

The fouling consisted mainly of barnacles, mussels and bryozoans, but also a new invasive species of tubeworm (Ficopomatus enigmaticus) was found each year (2013-2016) on the panels in this marina. All copper-based paints were highly effective against fouling. Only biofilm and silt were present on these panels.

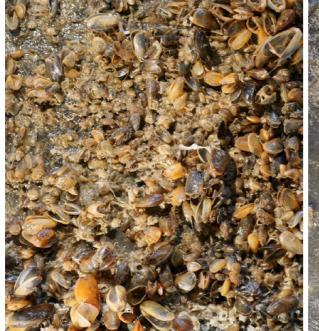
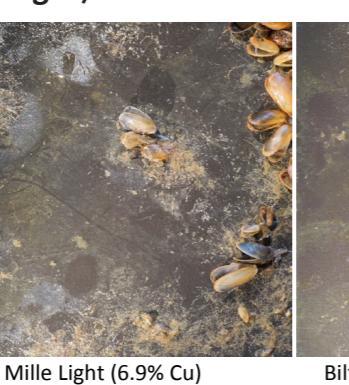
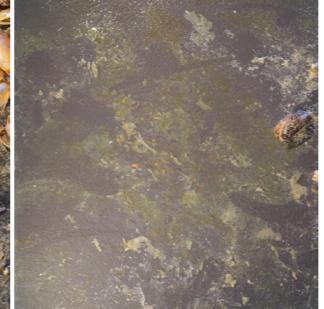
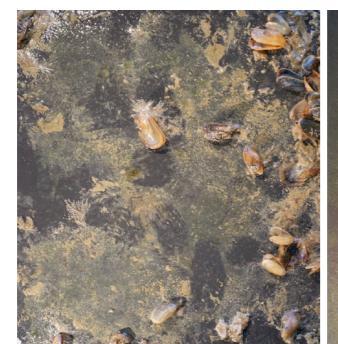
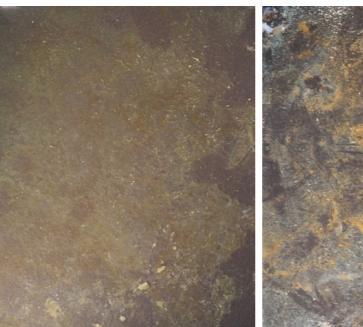
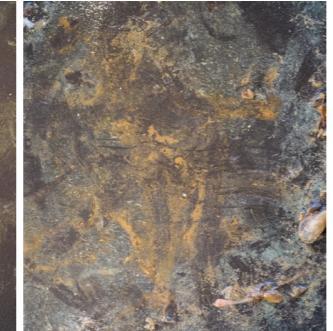
Photos of panels (Helsingør):

The fouling was dominated by barnacles and mussels, but bryozoans were also present. Most copper-based paints were highly effective against fouling. Only biofilm and silt were present on these panels. A few mussels were visible on the Mille Light Cu and Cruiser One paints.

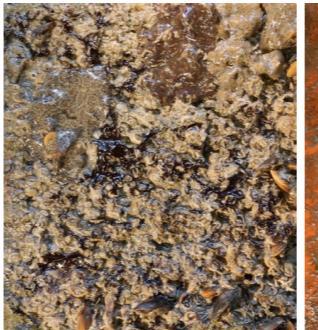
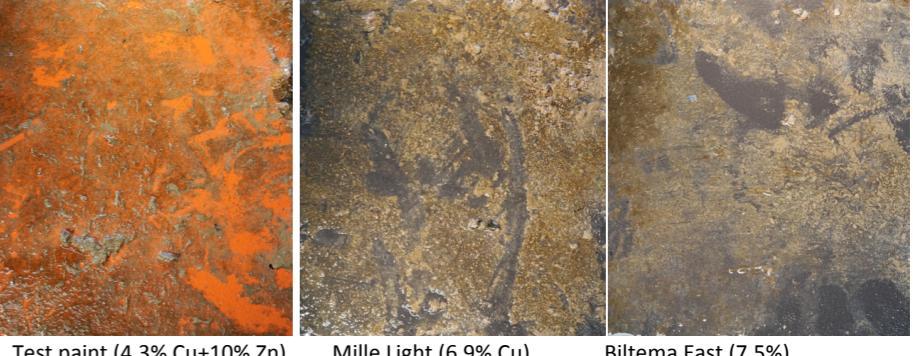
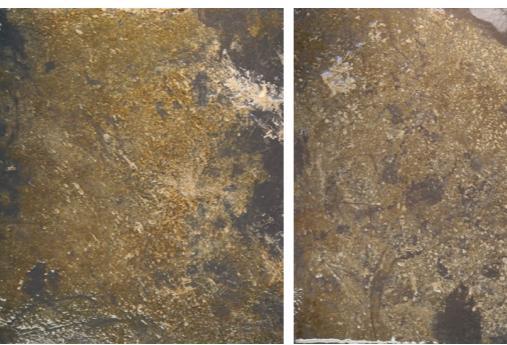
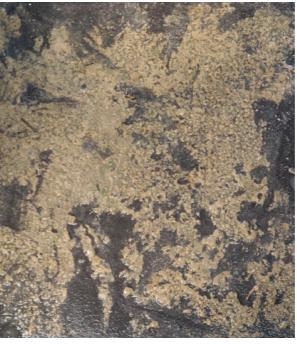
Photos of panels (Fiskebäck)

The fouling consisted mainly of barnacles, bryozoans and mussels but many other species occurred too including colonial tunicates, algae and hydroids. Both fouling intensity (% coverage of panel) and severity (hard fouling, multiple layers) was high in this marina over all years studied. All copper based paints were efficient against macroscopic fouling. Only biofilm, which can be removed with a gentle brush/sponge, was present on AF painted panels. Three of the copper-based paints (Biltema BS, Biltema West and MilleXtra) were effective against fouling during two full boating seasons (5 months x2) given that the coatings were only gently cleaned between seasons). This shows that fouling protection can be achieved without re-painting each year.

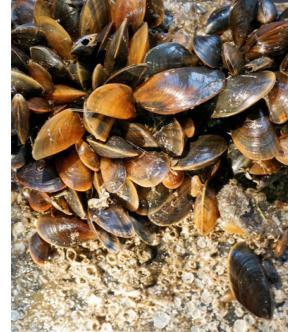
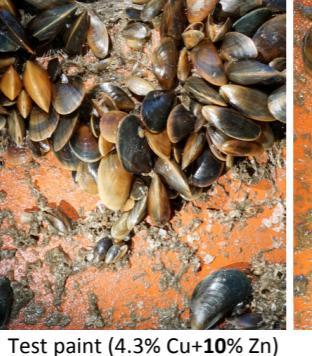
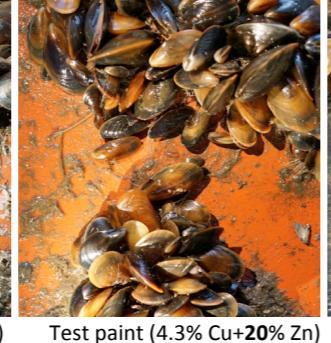
Photos of panels (Strömstad):

The marina is located close to the Kosterhavet National Park, an area with the highest species diversity along the Swedish coast, and also the highest fouling pressure. The fouling on the control panels was dominated by barnacles (bottom layer), mussels (high densities!) and tunicates (dominant during some years), but other species occur too including bryozoans, colonial tunicates, algae and hydroids. High quantities of mussels and tunicates are likely to be removed during movement of the boat; e.g. traces of mussel attachment indicate that mussels have fallen off the panels due to high densities (e.g. on Biltema East). The most efficient paint against macroscopic fouling was Biltema West (13% Cu) that had only biofilm present, which can be removed with a gentle brush/ sponge. Although several paints had mussels/traces of mussel attachment, most Cupaints were free from barnacles and reduced the total fouling considerably compared to the control panels.

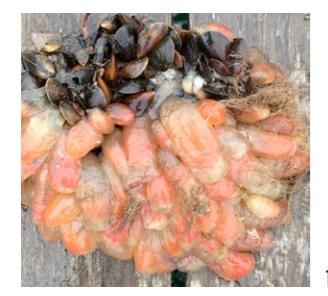
Photo of a control panel (Lago racing) in Strömstad 2016, for comparison.
