# SAFETY OF TAILINGS MANAGEMENT FACILITIES IN THE DANUBE RIVER BASIN

# WHAT IS THE DANUBE TMF PROJECT?

This brochure presents key outcomes of the Danube TMF project, including assessment of historical accidents, some basic tools to assess hazard and risk, an updated version of the TMF Checklist tool, a TMF inventory for the DRB and a pilot capacity building activity.

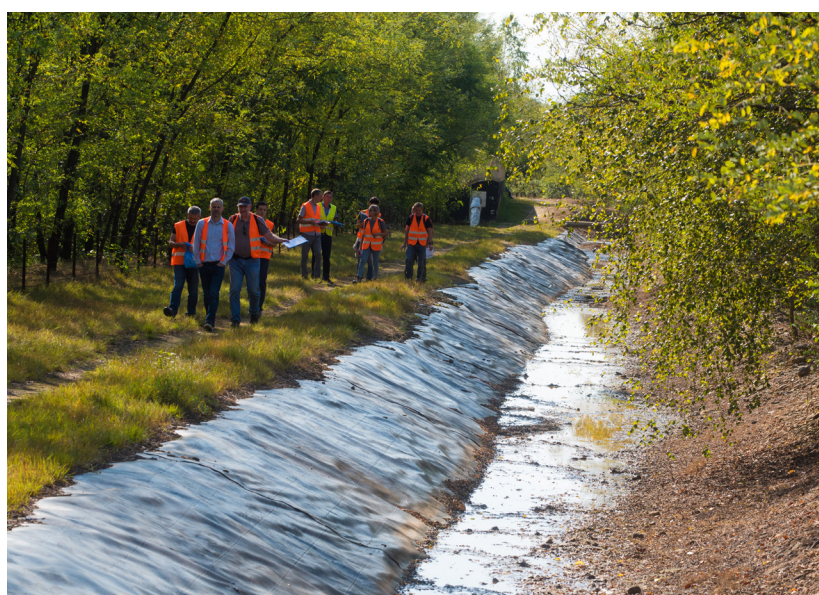
Visual check of the Aurul TMF: main drainage channel with impervious HDP screen (geo-membrane)

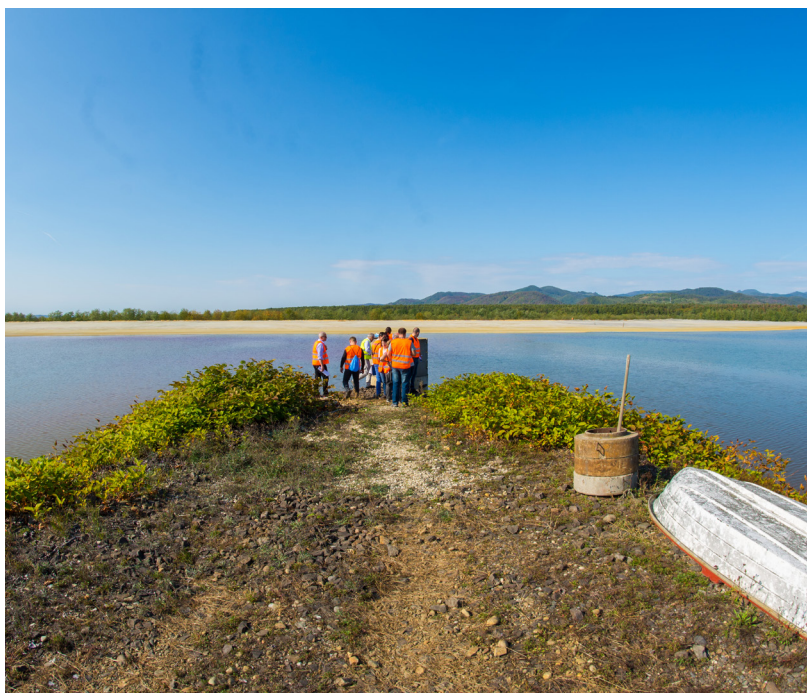
Visual check of the Aurul TMF: decant structure with water level measurement system.
