# SAFETY OF TAILINGS MANAGEMENT FACILITIES IN THE DANUBE RIVER BASIN

International Commission  
for the Protection  
of the Danube River

# WHAT IS THE DANUBE TMF PROJECT?

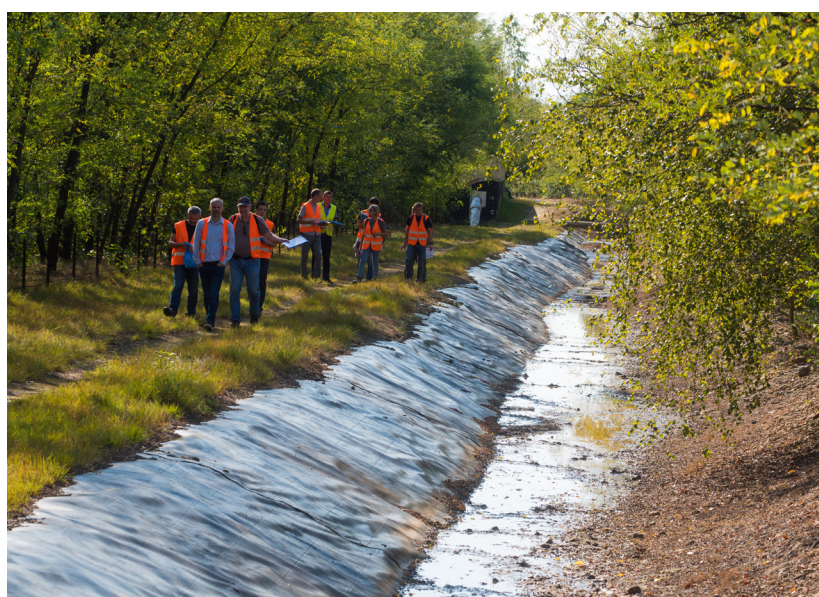
Visual check of the Aurul TMF: main drainage channel with impervious HDP screen (geo-membrane)
